# New Hampshire Volunteer Lake Assessment Program

## 2003 Biennial Report for Scobie Pond Francestown

NHDES Water Division Watershed Management Bureau 29 Hazen Drive Concord, NH 03301

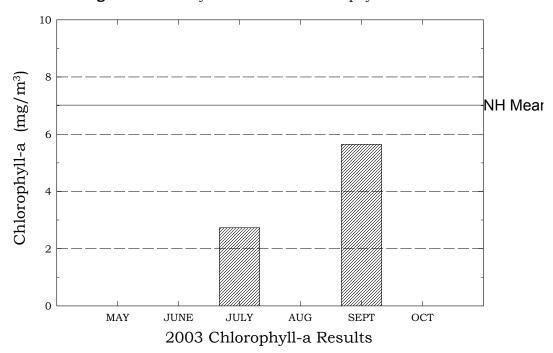
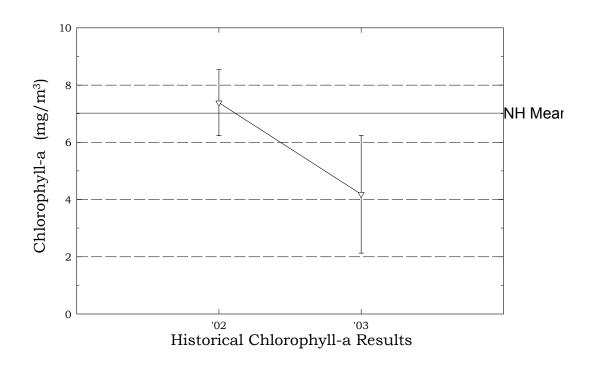
Figure 1. Monthly and Historical Chlorophyll-a Results

The current year data (the top graph) show that the chlorophyll-a concentration *increased* from July to September. The chlorophyll-a concentration in both months was *less than* the state mean.

The bottom graph shows historical annual mean chlorophyll-a concentration. In 2003, the mean concentration is *less than* the state mean.

Overall, visual inspection of the historical data trend line (the bottom graph) shows that chlorophyll has decreased from the 2002 season, meaning that chlorophyll levels have improved from last season. No trends can be determined with only to years of data. After 10 consecutive years of sample collection, we will be able to conduct a statistical analysis of the historic data to objectively determine if there has been a significant change in the annual mean chlorophyll-a concentration since monitoring began.

While algae are naturally present in all lakes/ponds, an excessive or increasing amount of any type is not welcomed. In freshwater lakes/ponds, phosphorus is the nutrient that algae depend upon for growth. Algal concentrations may increase with an increase in nonpoint sources of phosphorus loading from the watershed, or inlake sources of phosphorus loading (such as phosphorus releases from the sediments). Therefore, it is extremely important for volunteer monitors to continually educate residents about how activities within the watershed can affect phosphorus loading and pond quality.

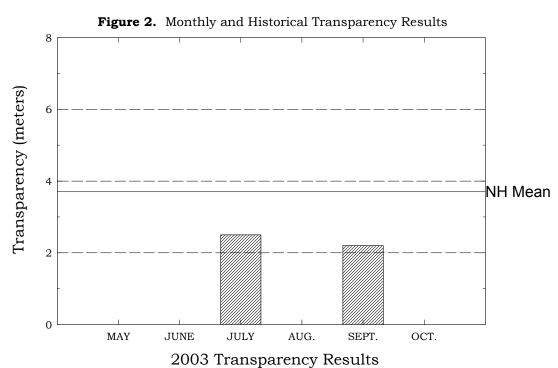
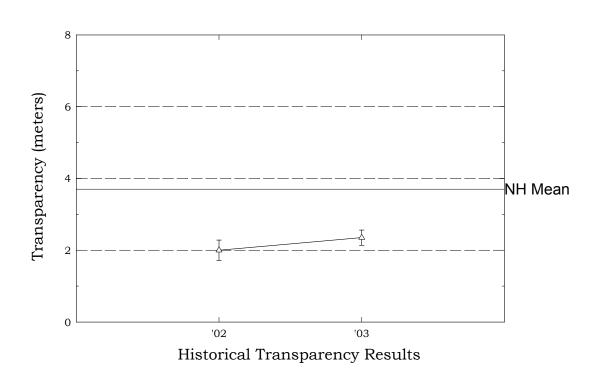
The current year data (the top graph) show that the in-lake transparency **decreased** from July to September. The transparency in both months was **less than** the state mean.

The bottom graph shows historical annual mean transparencies. In 2003, the mean transparency is *less than* the state mean.

Overall, visual inspection of the historical data trend line (the bottom graph) shows that the transparency was stable over the two year period. However, this is based on limited data. After 10 consecutive years of sample collection, we will be able to conduct a statistical analysis of the historic data to objectively determine if there has been a significant change in the annual mean transparency since monitoring began.

Typically, high intensity rainfall causes erosion of sediments into lakes/ponds and streams, thus decreasing clarity. Efforts should continually be made to stabilize stream banks, pond shorelines, disturbed soils within the watershed, and especially dirt roads located immediately adjacent to the edge of tributaries and the pond. Guides to Best Management Practices designed to reduce, and possibly even eliminate, nonpoint source pollutants, such as sediment loading, are available from DES upon request.

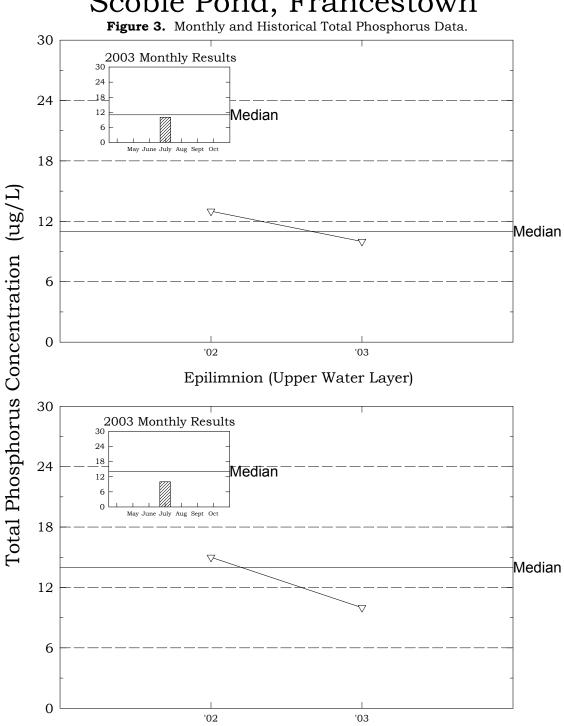
The current year data for the epilimnion (the top inset graph) show that the phosphorus concentration in July was *less than* the state median. No phosphorus samples were collected in September.

The top graph shows historical annual mean epilimnetic phosphorus concentrations. Collecting more than one phosphorus data set per year will allow a better analysis of annual mean trend data.

The current year data for the hypolimnion (the bottom inset graph) show that the phosphorus concentration in July was *less than* the state median.

The bottom graph shows historical annual mean hypolimnetic phosphorus concentrations. Collecting more than one phosphorus data set per year will allow a better analysis of annual mean trend data.

Overall, visual inspection of the historical data trend line for the epilimnion show that phosphorus decreased from last years sample, which means that the concentration has *improved* in the epilimnion since monitoring began.

Overall, visual inspection of the historical data trend line for the hypolimnion shows that phosphorus decreased from last years sample, which means that the concentration has *improved* in the hypolimnion since monitoring began.

One of the most important approaches to reducing phosphorus loading to a waterbody is to continually educate watershed residents about its sources and how excessive amounts can adversely impact the ecology and value of lakes and ponds. Phosphorus sources within a lake or pond's watershed typically include septic systems, animal waste, lawn fertilizer, road and construction erosion, and natural wetlands.
